***Re: Miami Seaquarium Life Safety and Electrical Installations Review Findings***

This report is a summary of observations noted during my October 10 – 11, 2003 walkthrough of the Miami Seaquarium located at 4400 Rickenbacker Causeway, Miami Florida 33149.

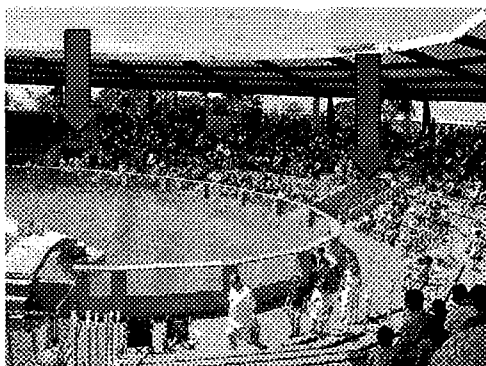
**Killer Whale Show:** The picture below shows the two exits (depicted by arrows) utilized by spectators for exiting the show. If the closest exit were to be blocked in an emergency, spectators on the near (North) side of the photo would have no alternate means of egress, a violation of NFPA 101 – 2000: 13.2.5.1: *“Exits shall be located remotely from each other and shall be arranged to minimize the possibility that they might be blocked in an emergency.”*

As stated previously, four (4) exits are required for this type of occupancy. An article in the October 11, 2003 edition of *The Miami Herald* states that the Miami-Dade County Fire Marshall’s office plans to allow this violation to be abated by only adding one (1)

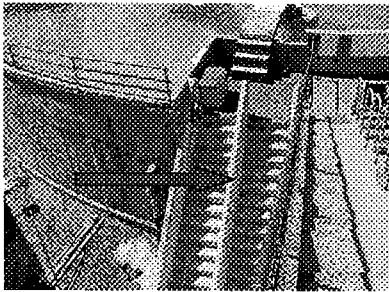
additional exit. This will result in a total of three (3) exits instead of the four (4) required per NFPA 101. I am not aware of where the additional exit will be added. There are presently two (2) employee only exits from the facility. However, the employee exit on the North side would require spectators to exit through the operating plant of the facility and might expose spectators to additional hazards by exiting through a more hazardous area. This would be a violation of NFPA 101 – 2000 13.2.5.2: *“Means of egress shall not be permitted through kitchens, storerooms, restrooms, closets, or hazardous areas as described in 13.3.2.”* Also, the employee only exit on the South side does not appear wide enough to sufficiently accommodate the required occupant load nor is it designed to accommodate children in strollers as well as spectators in wheelchairs. In addition, exit access would be partially restricted by the wheelchair designated area that is located just prior to the potential exit access route.

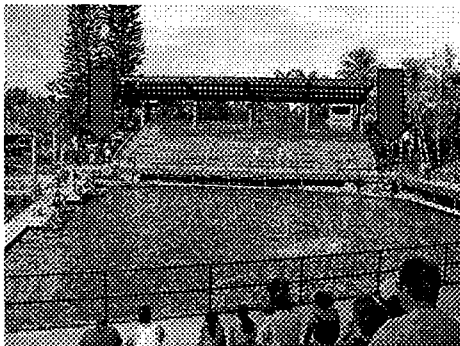
**Flipper Show:** Only two exits are provided, four are required for this type of occupancy. Also, if the far (North East) exit were to be blocked, spectators on the South side would have no alternate means of egress.

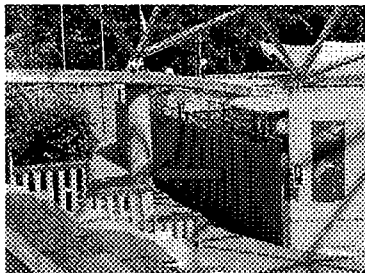
**Golden Dome:** Two exits are provided; four are required. Also, the picture below reveals the large support pillar located on the West side exit partially restricting egress.

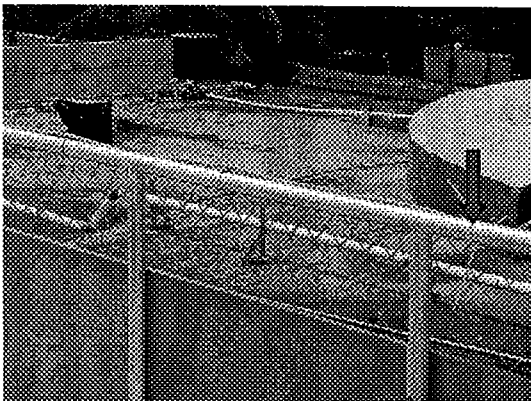
*Misuse of flexible electrical cords:* There were numerous examples of flexible electrical cords attached to building structures via cable ties or other means. This practice represents a significant hazard to visitors and employees of the Miami Seaquarium – a fray in the flexible cord could potentially energize a metal structure. Article 400 – 8 (4) of the National Electrical Code prohibits flexible cords from being attached to building structures. Some of these cords are less than 50 volts and are therefore exempted from this requirement. However, there are numerous electrical cords  $\geq$  50 volts attached to conduit or other building structures. Listed below are some typical examples observed during my walkthrough.

Photo 1: Top of Reef Tank – Yellow electrical extension cord attached to chain link fence.

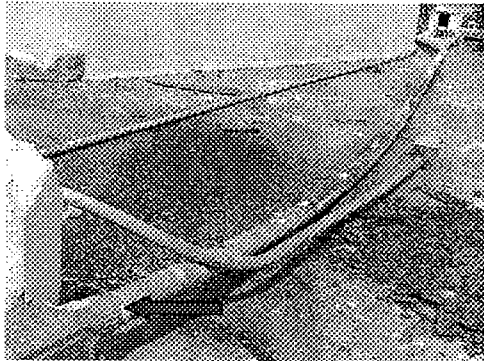
Photo 2: Top of Reef Tank: Flexible cord attached to conduit and being used in a permanent manner.

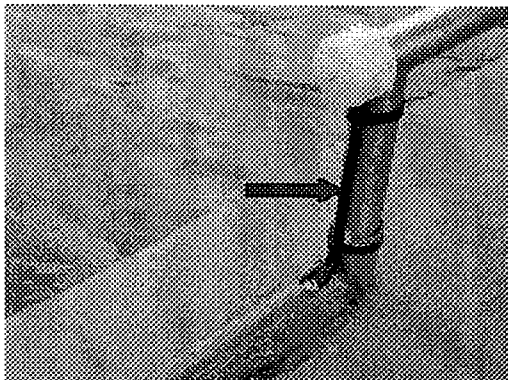
Photo 3: Flexible electrical cord attached to Top Deck Dolphin Show Tank:

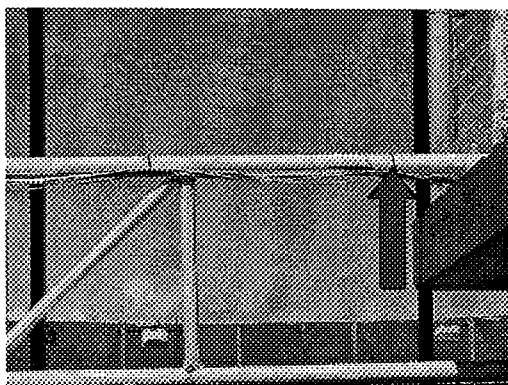
Photo 4: Flexible electrical cords attached to metal structure at top of Reef Tank.

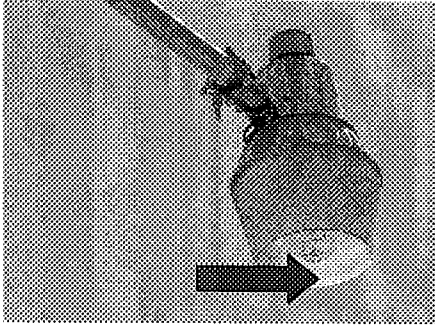
**Suitability of Light Fixtures for Outdoor Use:** During my walkthrough, I observed approximately fifteen (15) outdoor lighting fixtures that do not appear to be acceptable for use in a wet outdoor environment, a violation of Article 410-4. (a) of the National Electrical Code. An example of one of these lighting fixtures is shown in photo 5.

Photo 5: Lighting fixture at top of Reef Tank.

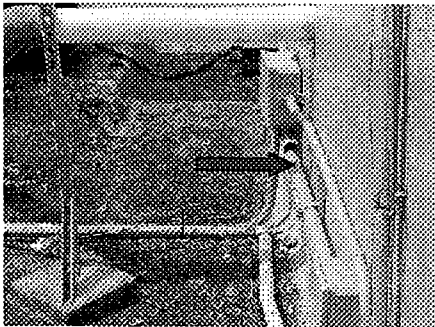
**Guarding of Live Parts:** Article 110-27. (a) of the National Electrical Code requires live electrical components operating at  $\geq 50$  volts to be guarded against accidental contact.

Photo 6: Conduit at top of Reef Tank – Damaged, potentially exposing live conductors to Miami Seaquarium employees.

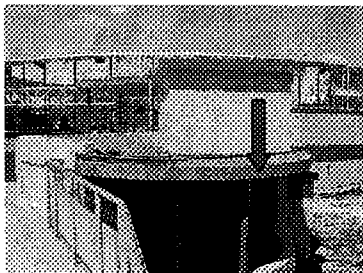
Walking working surfaces was not emphasized during my walkthrough, however, I did note one potential hazard. An employee was sweeping off a roof with a broom near the top of the Reef Tank – potential fall hazard. OSHA 29 CFR 1910.23 (c)(1) requires fall protection, such as guardrails, when employees are exposed to fall hazards  $\geq 4$  feet.

Photo 7: Roof at top of Reef Tank
